CERTIFICATE of QUALITY TEST

Test report - No. 10996.03 / 14

Test of the dynamic-mechanical robustness of the **Incremental Encoder HOGS 151** under defined environmental conditions.

Incremental Encoder	HOGS 151 DN 5000
SN	700001050791
delivery date of the EUT	17 December 2014

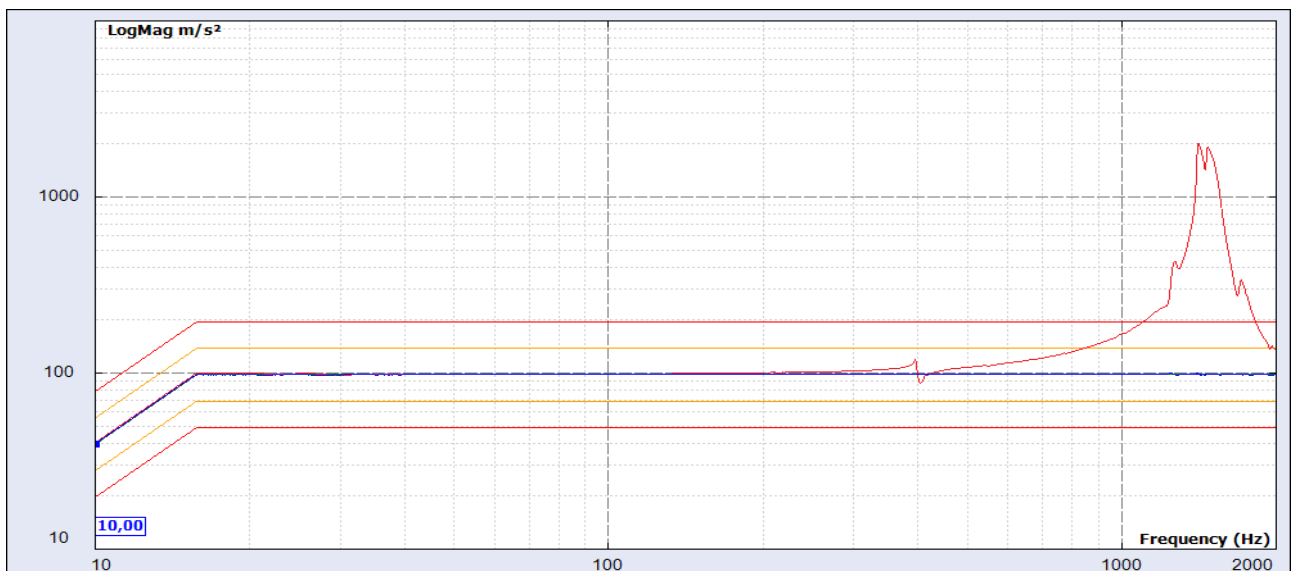
Vibration, sinusoidal, Y-axis, - control channel, - acceleration at specimen (channel 3)

specimen	not operating
frequency range	10 - 2000 Hz
amplitude	10 – 16 Hz ± 10 mm
acceleration	16 – 2000 Hz 91.1 m/s ² (10 g)
sweep rate	1 octave / min
number of axes	3
test duration	1:30 h (2 cycles per axis / 3 x 0:30 h)

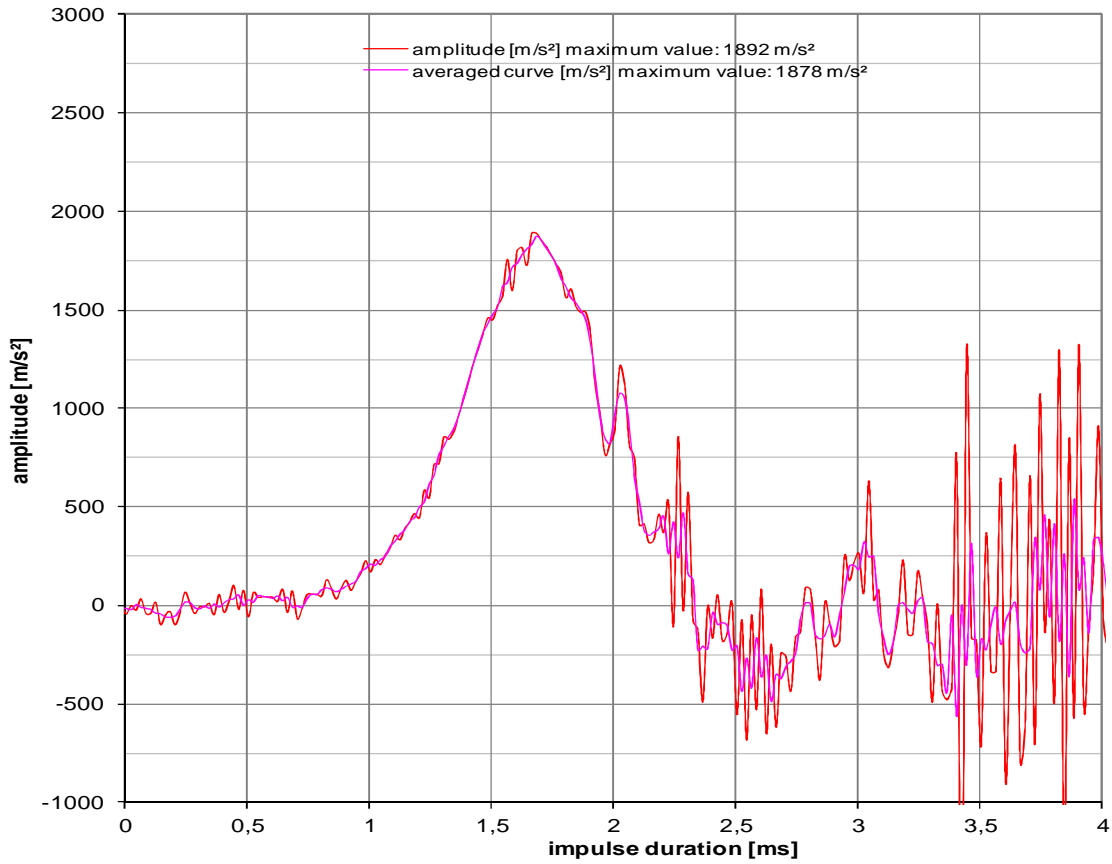
Shock, half-sine (control channel)

specimen	not operating
acceleration	1962 m/s ² (200 g)
pulse duration	app. 1.5 ms
number of directions	6
test duration	18 shocks (3 shocks in each direction)

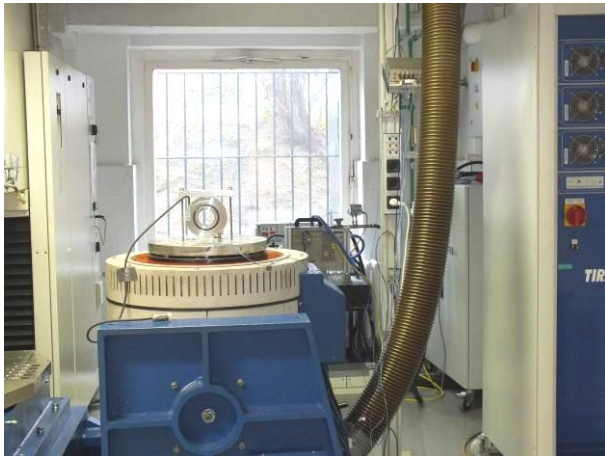
picture 1
Incremental Encoder HOGS 151
on the vibration test device
during vibration test in X-axis

This aluminum fixture with the specimen was directly installed in the respective axis on the vibration / shock table, see pictures in appendix 2

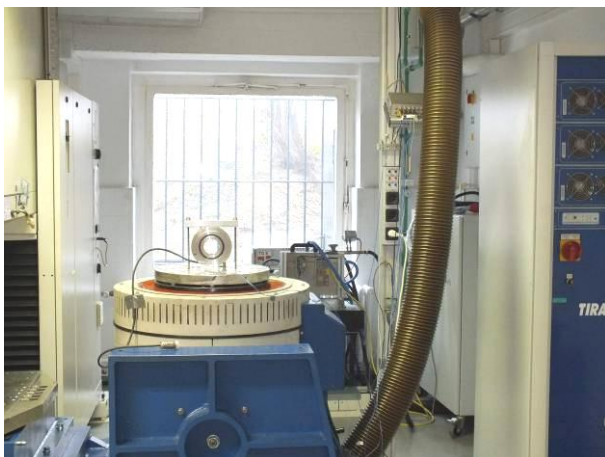
picture 3
Incremental Encoder HOGS 151
specimens on the vibration test device
during vibration test in Y-axis

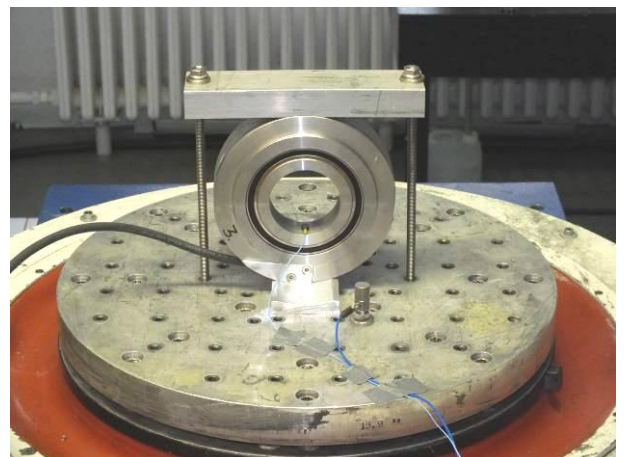
picture 4
Incremental Encoder HOGS 151
on the vibration table with acceleration sensors
during vibration test in Y-axis

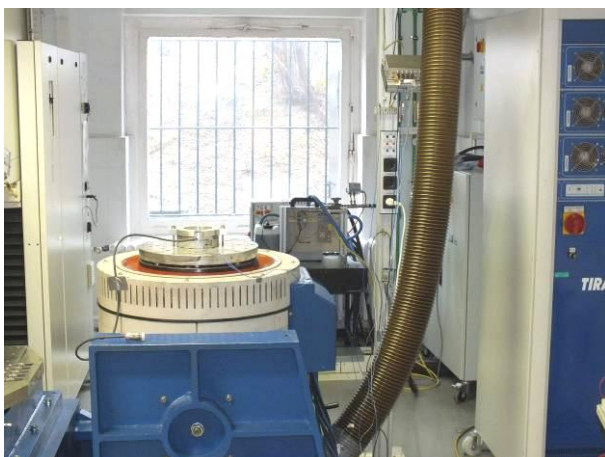
picture 5
Incremental Encoder HOGS 151
specimen on the vibration test device
during vibration test in Z-axis

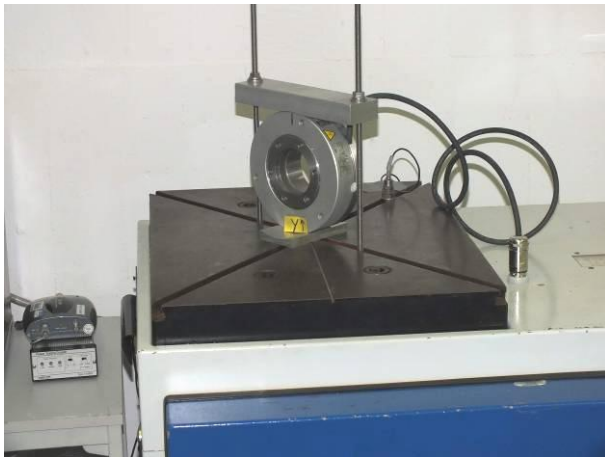
picture 9
Incremental Encoder HOGS 151
on the shock table with acceleration sensor
during shock test in Y-axis, positive direction

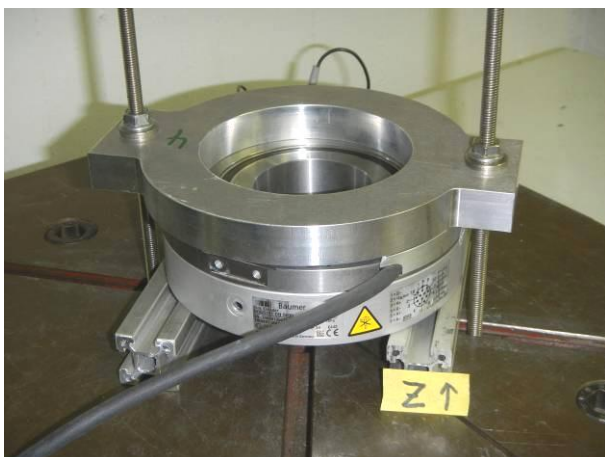
picture 11
Incremental Encoder HOGS 151
on the shock table with acceleration sensor
during shock test in Z-axis, positive direction
